# Manhole Inspection Summary

Manhole # S45G\_\_007MH

Insp Date: **8/20/08 12:18 PM**

**Location** Address: **CASTLE**

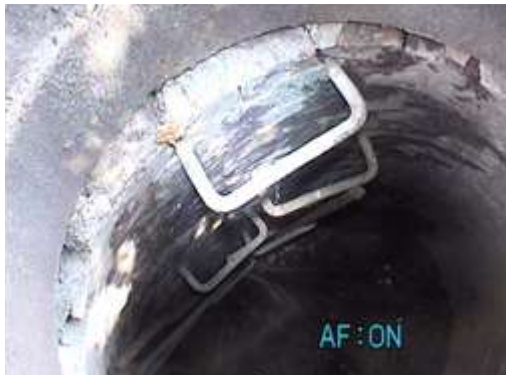
Defect 2

Condition: ☐ Sound ☐ Cracked ☐ Root Intrusion ☒ **Loose Brick** ☐ Deteriorated

Infiltration: ☐ None ☒ **Joint** ☐ Cracks ☒ **Mortar** ☐ Roots ☐ Wall

Loose brick

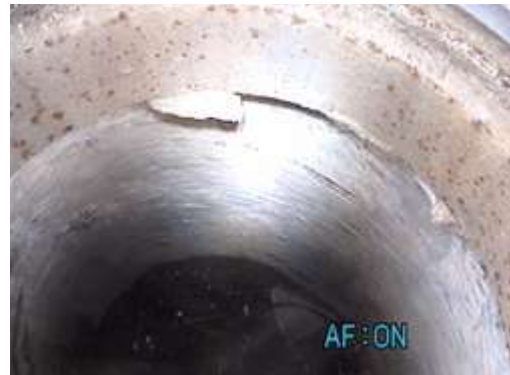
Defect 1

Frame leaks

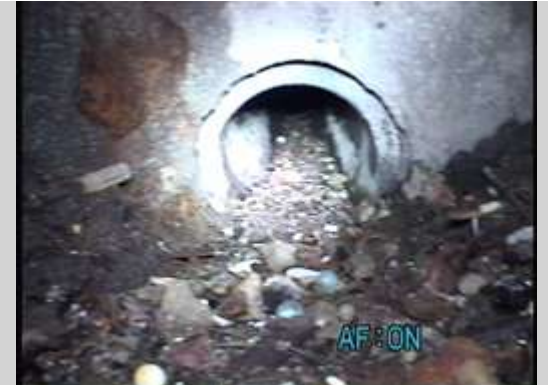
12 O'Clock Outflow

8 in. Circular Gravity Sewer  
Pipe Out @ 12 O'Clock

Deposits: ☐ None ☐ Mud ☐ Sludge ☒ **Debris** ☐ Grease

Silt Depth: **0.15** (in.) Deposits Extent: **Light**
